Manhole Inspection Summary

Manhole # S15CC1009MH

Insp Date: **2/1/07 2:05 PM**

Location Address: **3800 PALL MALL RD**

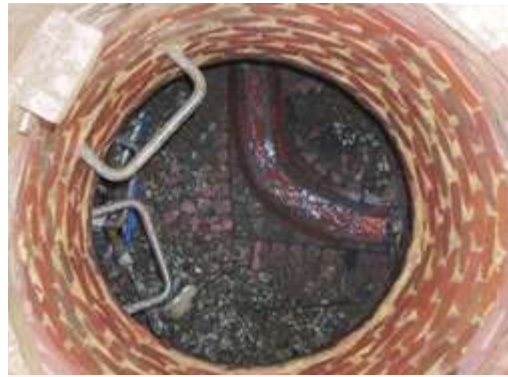
Top View

Corroded steps. Evidence of surcharge - Bench debris. Channel debris.

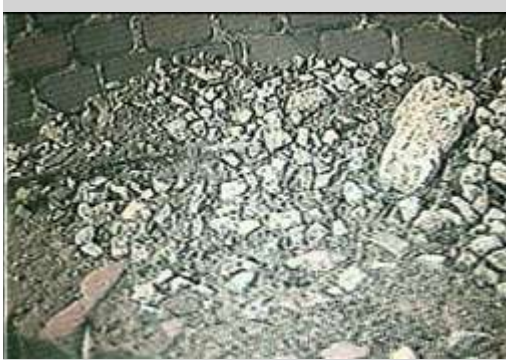
Defect

Barrel deterioration and infiltration. Bench debris.

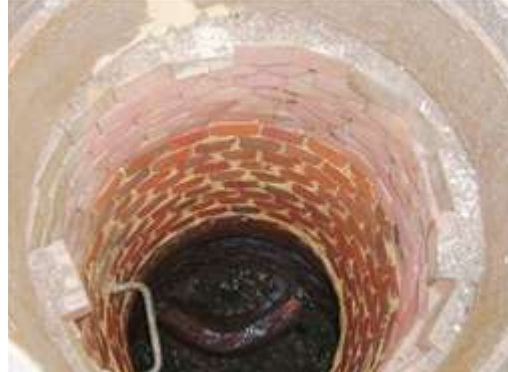
Defect

Frame leaks. Adjustment deterioration, loose brick and infiltration - other side.

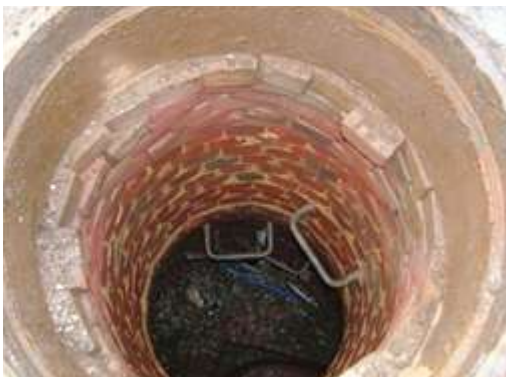
Defect

Frame leaks. Adjustment deterioration, loose brick and infiltration.

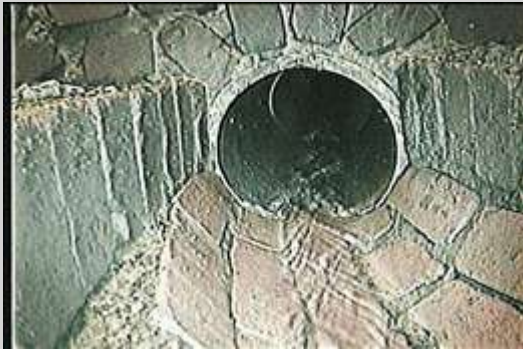
8 in. Circular Gravity Sewer Pipe Out @ 12 O'Clock

Infiltration: **Evidence** Pipe Seal Cond: **Unknown**

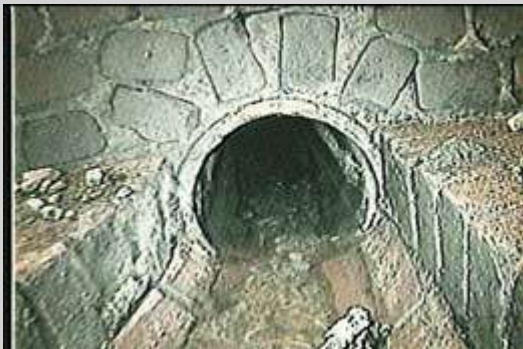
8 in. Circular Gravity Sewer Pipe In @ 3 O'Clock

Channel deterioration.

Deposits: ☐ None ☐ Mud ☐ Sludge ☒ Debris ☒ Grease

Silt Depth: **0.5** (in.) Deposits Extent: **Light**

Infiltration: **Evidence** Pipe Seal Cond: **Unknown**
